Corrosion

NATIONAL ASSOCIATION OF CORROSION ENGINEERS

CORROSION—September, 1954

Pitting Corrosion Characteristics of Aluminum*

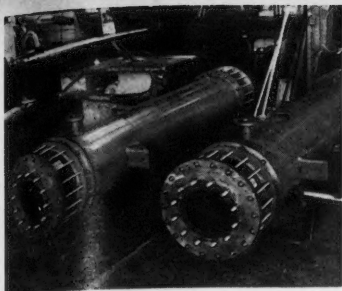
THIS MONTH'S COVER—Shown here are two of 12 tubular impervious graphite heat exchangers built jointly by the Colonial Iron Works Company and the National Carbon Company, Cleveland. The exchangers will replace corroded stainless steel units used in the production of rayon. Impervious graphite is more corrosion resistant in some environments than stainless steels.

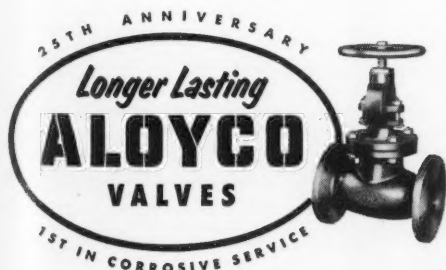
Cross-section shows how jackets extend to edge of flanges and include stuffing boxes on this Aloyco 1105 Jacketed Gate Valve. Also shown are the non-fouling, ball-and-socket split-wedge disc and mar-proof rocker-type gland plate and follower.

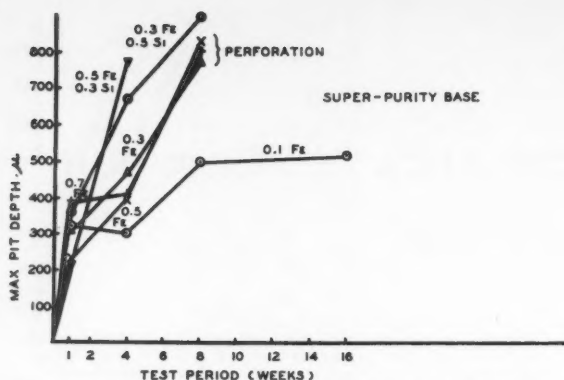
Figure 1—Influence on the rate of pitting of iron additions to super purity aluminum.

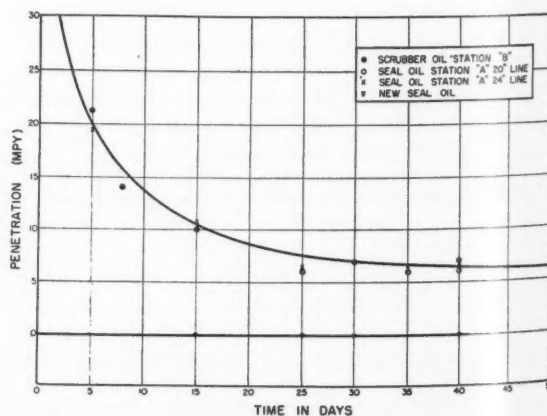
Figure 1—Corrosion rate based on weight loss.

The rate curves for these tests are shown in Figure 1. It is evident from the rate curves that the initial

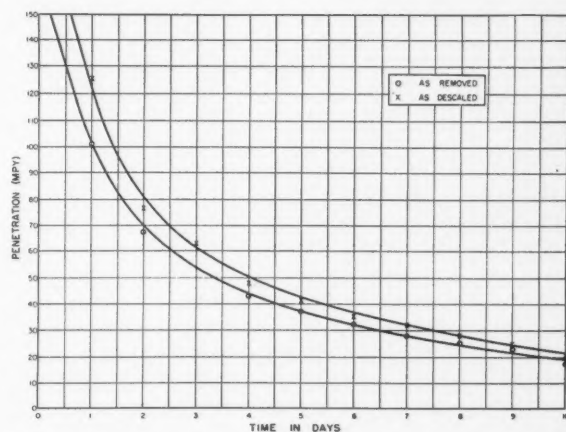
Figure 4—Corrosion rate, based on weight loss, before and after descaling coupons.

Figure 4 represents the graphical results of these tests. In order to estimate the thickness of the scale, the test strips were weighed before and after descaling. Both the as-removed (with scale in place) and the descaled (scale removed) results are plotted. It is to be noted that the shape of the curves in Figures 1 and 4 are similar and that the initial corrosion rate is high. From the weight loss on descaling it is observed that initially the scale weight decreases as corrosion proceeds. At the end of 9 days the corrosion rate dropped to 23 mpy and the scale reduced to 4 mils. This is indicative of a diffusion type reaction where the permeability of the film is the controlling factor.² The corrosion rate is decreasing with time, which indicates a more protective-type surface film. With reference to Figure 1, at the end of thirty days a steady state is reached and the corrosion rate approached a steady value. At this point the scale has possibly become better oriented on the metal surface and, therefore, less porous and more protective. However, the scale does not completely protect the metal because after forty days the corrosion rate still is appreciable. This was also observed by Har- inghauzen and Was³ in their studies of corrosion by

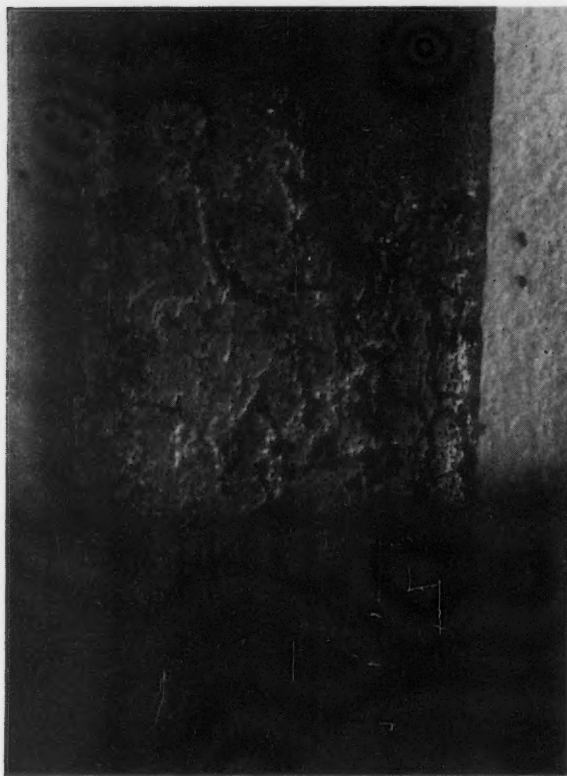
Figure 5—Copper test strip after 10 days in seal oil from Station A, 9X.

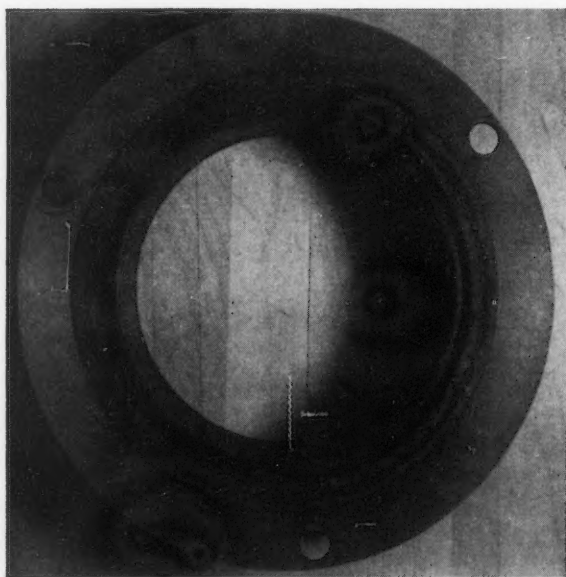
Figure 6—Face and bearing surface of oil-sealing sleeve.

Laboratory studies have shown quite conclusively that the frequent failures of the phosphor bronze oil-sealing sleeves are due to iron sulfide particles which have gained entrance into the circulating oil.

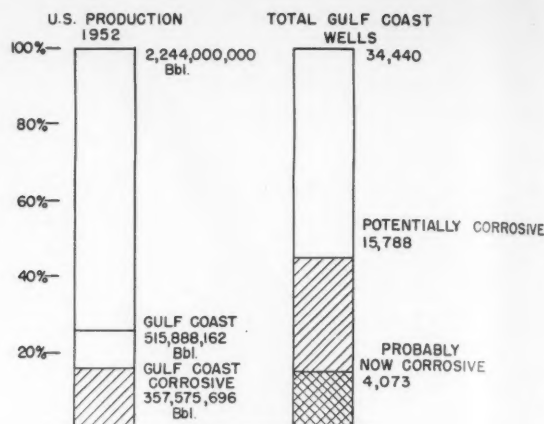
Figure 1—Comparison of corrosive and non-corrosive production.

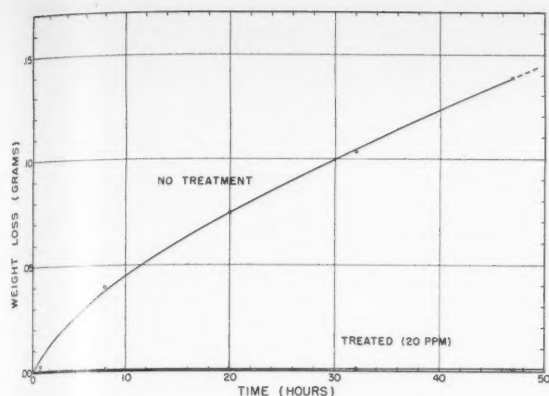
Figure 2—Corrosion rate curves. (One atm. carbon dioxide—produced oil and brine.)

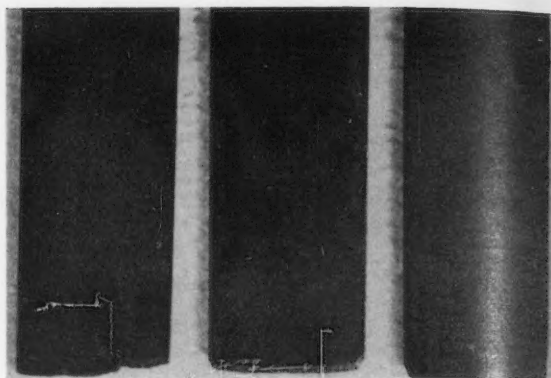
Figure 3—Corrosion coupons from arsenic-inhibited wells.

Figure 4—Tubing failure from arsenic-inhibited well.

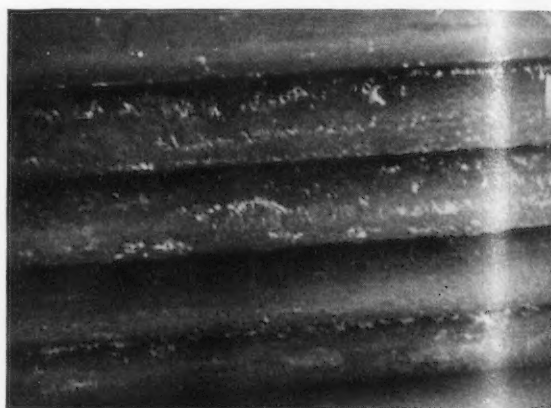
Figure 5— As_2O_3 scale on exterior of tubing.

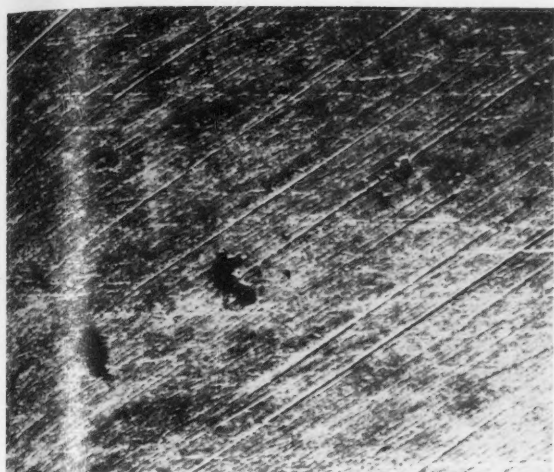
Figure 7—Laboratory coupon. 5 ppm arsenic treatment. Approx. X 25.

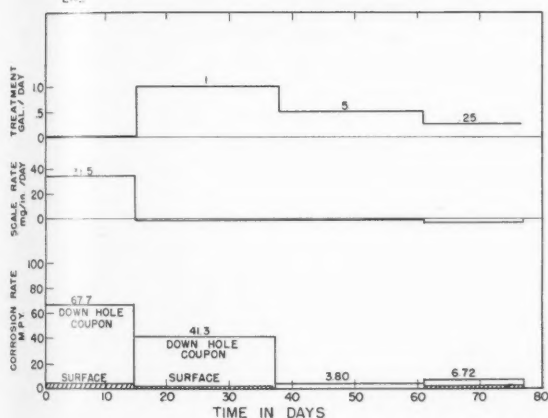
Figure 9—Effect of inhibitor Conoco T-12.

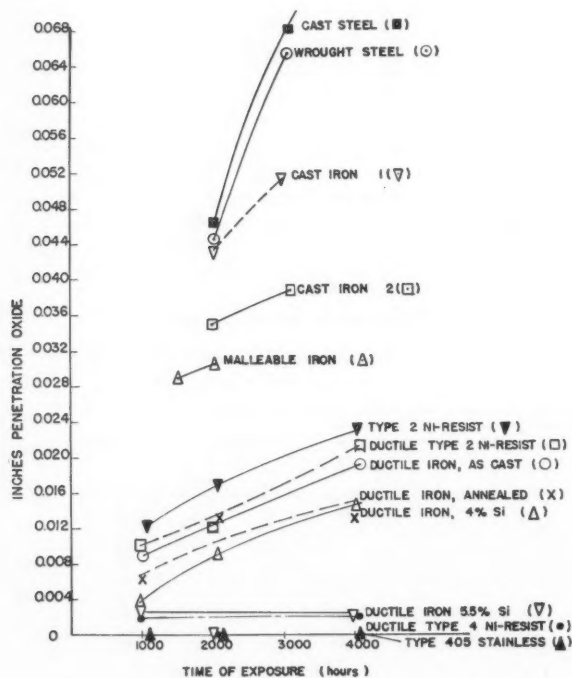
Figure 2—Metal loss vs. time of exposure at 1300 degrees F.

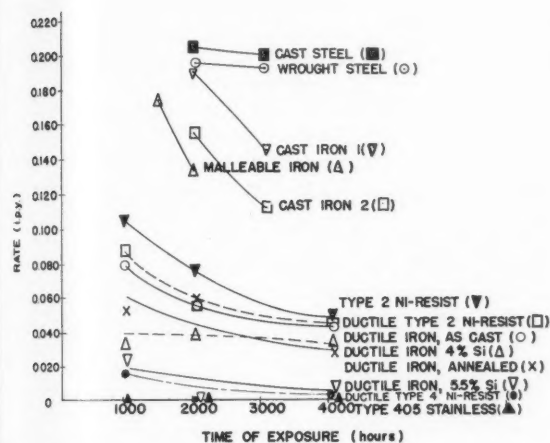
Figure 3—Rate of oxidation vs. exposure time at 1300 degrees F.

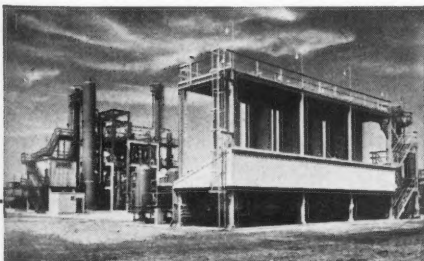
Hydrogen is burned with chlorine in these towers to produce hydrogen chloride. Nickel sleeves protect reactant feed lines. In the same plant, Nickel domes collect chlorine over electrolytic cells at temperatures in excess of 1000°F.

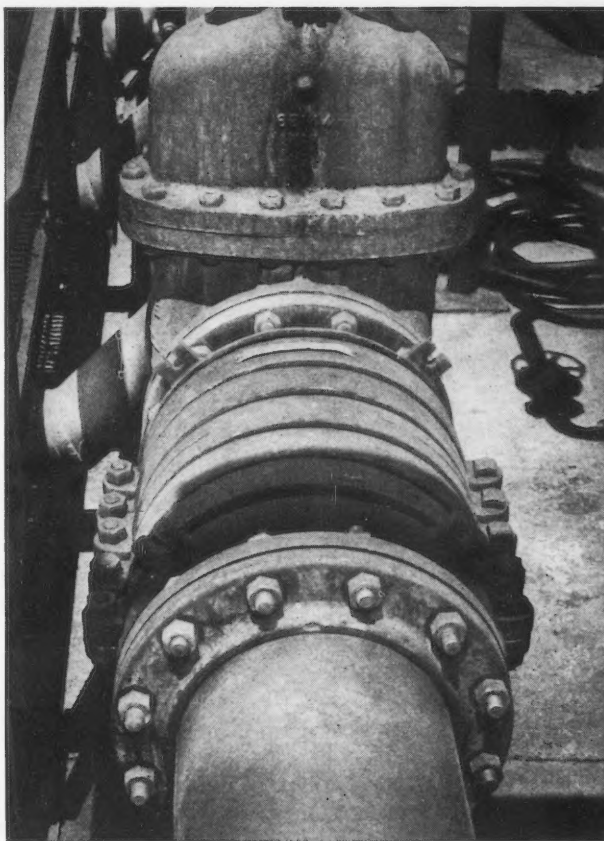
Hot chlorine and hydrogen chloride line in a carbon tetrachloride plant, showing an Inconel expansion joint and Inconel flange bolts. Elsewhere, this plant uses 3" Inconel furnace pipes to heat process gases for chlorinating hydrocarbons.
